Innovative
Inspection of PCB
Top and Bottom
Sides

iS6059 Double-Sided Inspection

Simultaneous optical quality control from above and below

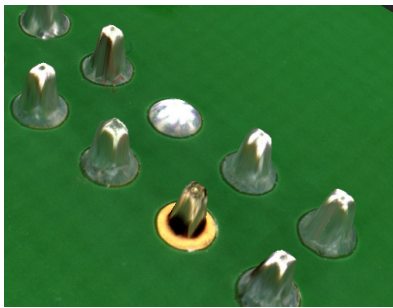
Insufficient wetting (front) and missing pin (back)
