## Wire Bond Inspection

AOI and AXI Systems for Reliable Inspection of Bond Wires in Electronics Manufacturing

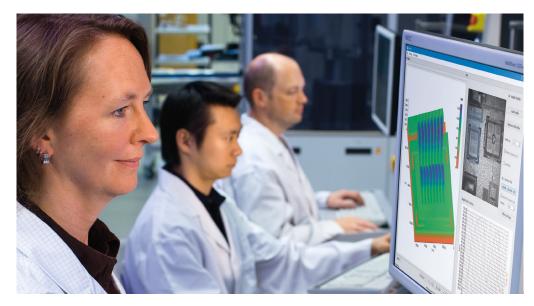
Wire bond inspection with Viscom SI software

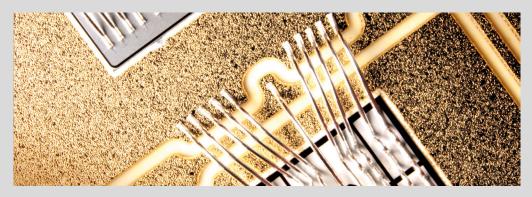
Bonded substrate from power electronics

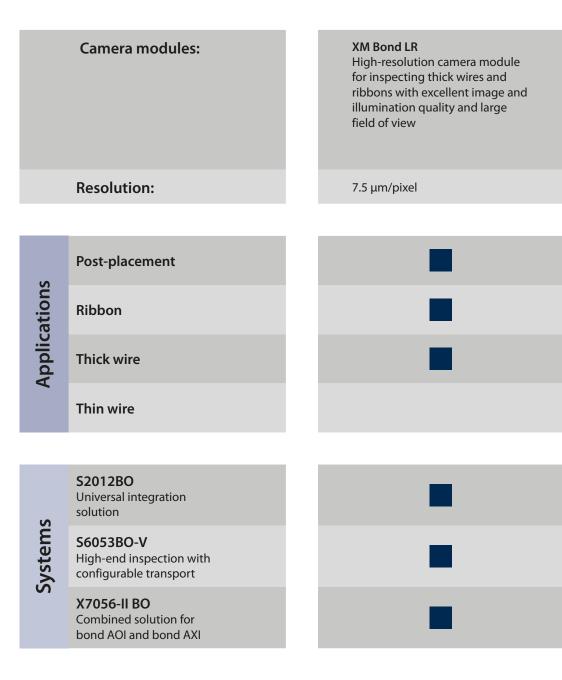
XM Bond HR Universal high-resolution camera module with excellent image and illumination quality and large field of view	XM Bond 3D Module Universal high-resolution 3D sensor technology especially for wire bond inspection	XM Bond VR High-resolution camera module designed specifically for thin-wire inspection
4.5 μm/pixel	4.5 μm/pixel	2.3 μm/pixel
